REHABILITATION OF NAVIGATION LOCK WALLS: CASE HISTORIES

James E. McDonald

December 1987

Final Report

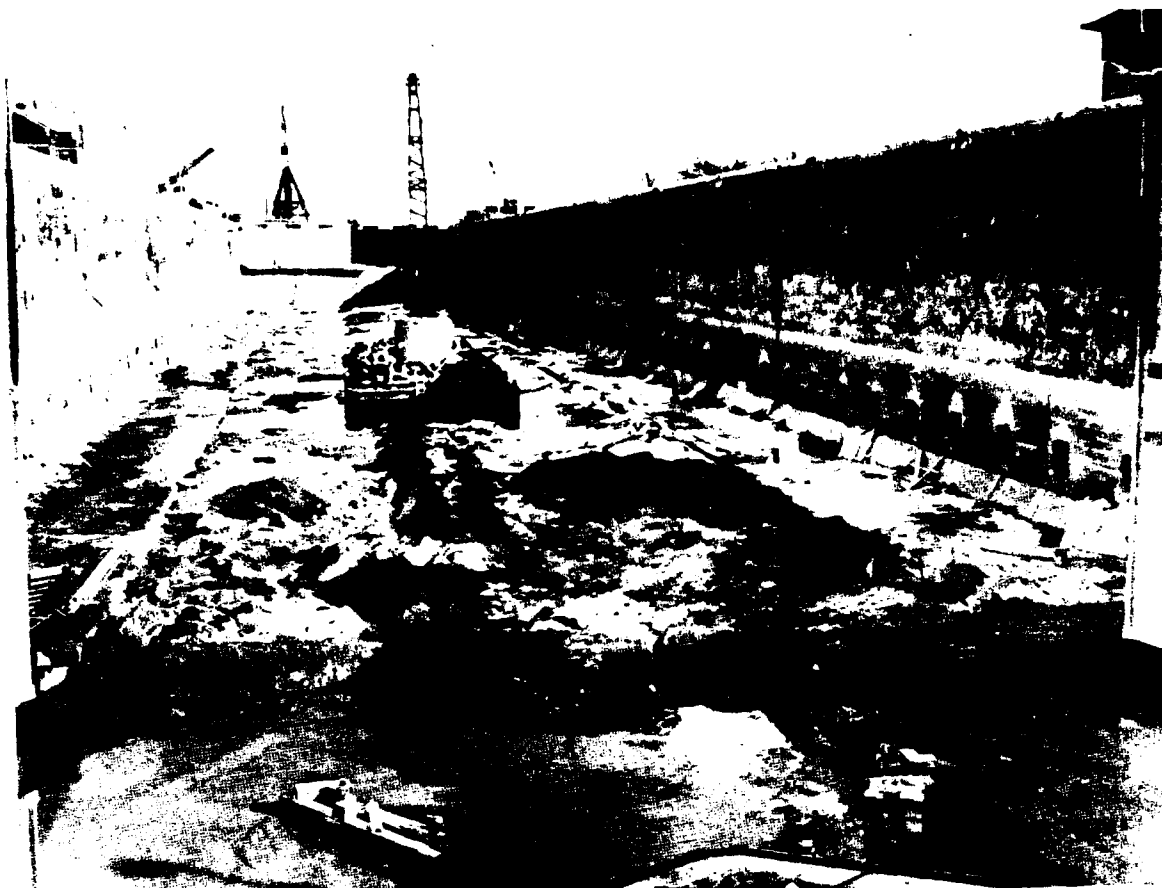
Figure 5. Lock chamber dewatered for repairs, 1952, Marseilles Lock

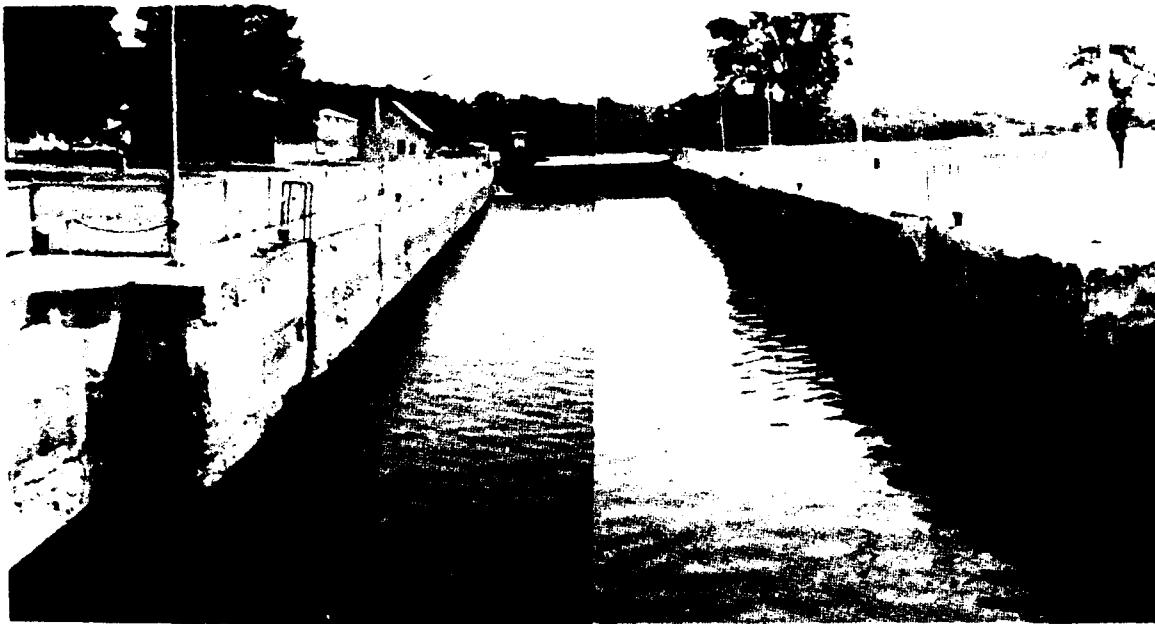
49. After 55 years exposure to the elements, lock concrete surfaces were severely scaled (Figures 17 and 18). An investigation was initiated in 1977 to determine the extent and causes of the concrete deterioration. Two 6-in.-diam holes were core drilled vertically through the landside lock wall and 5 ft into the underlying bedrock. In addition, 6-in.-diam cores were obtained from a total of 12 horizontal and vertical holes drilled to depths of

Figure 17. General view of lock looking upstream 1977,
Old Lock No. 14, Mississippi River

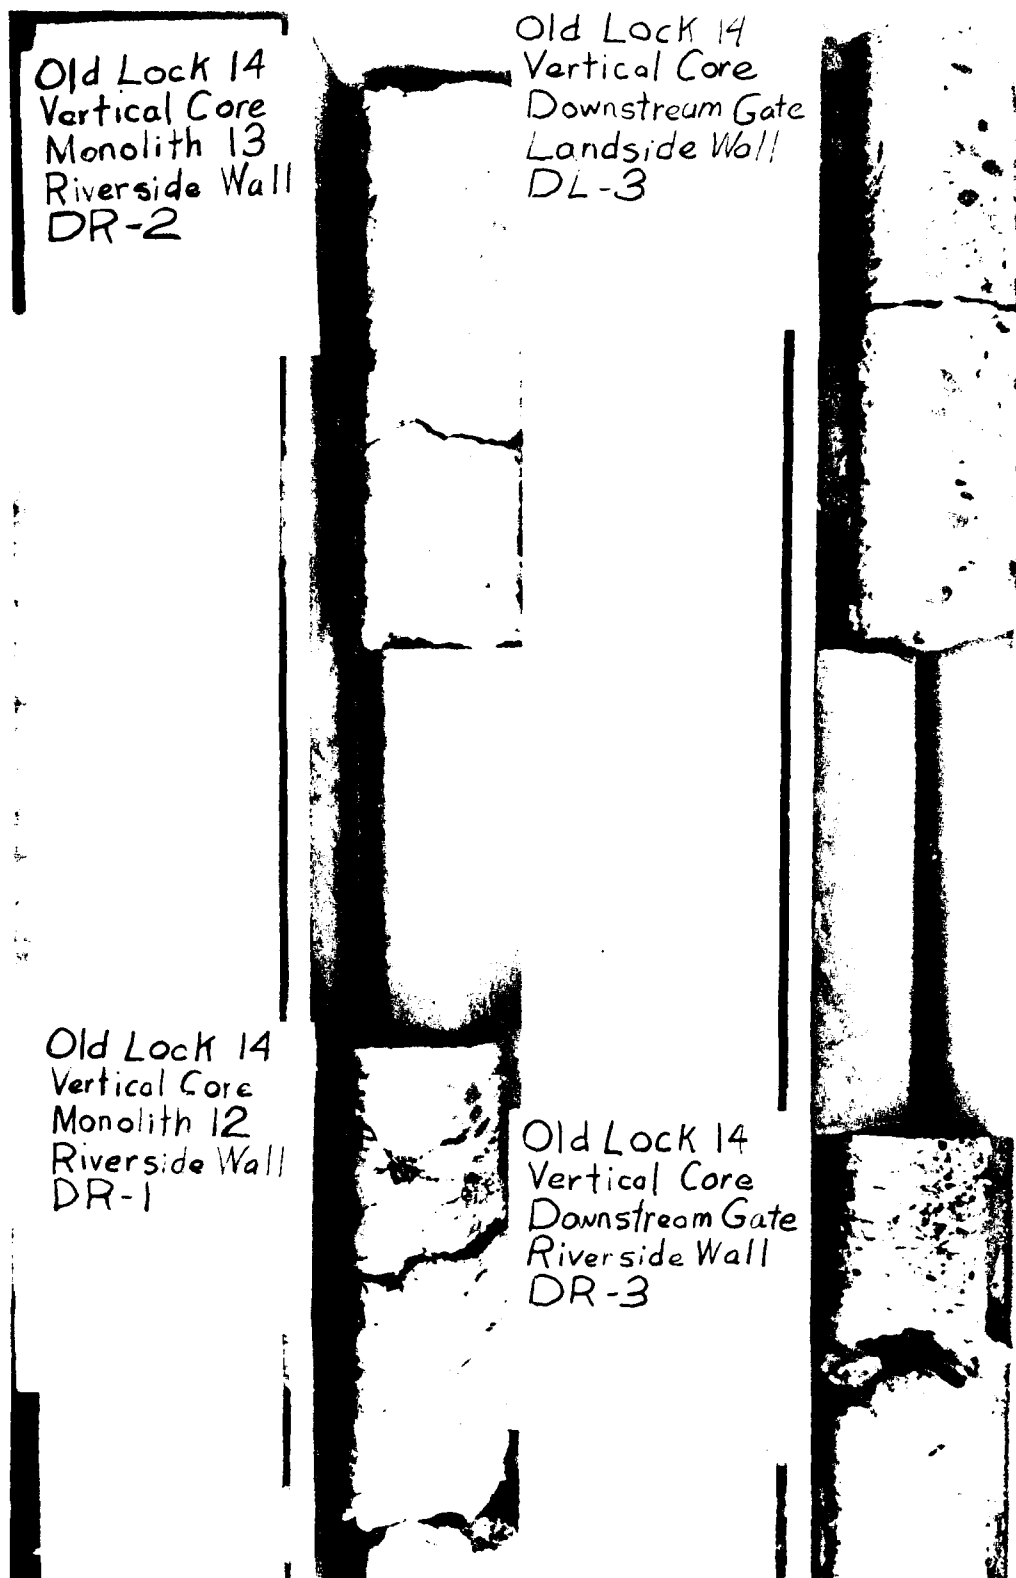
Figure 19. Photographs of selected concrete cores, 1977,
Old Lock No. 14, Mississippi River

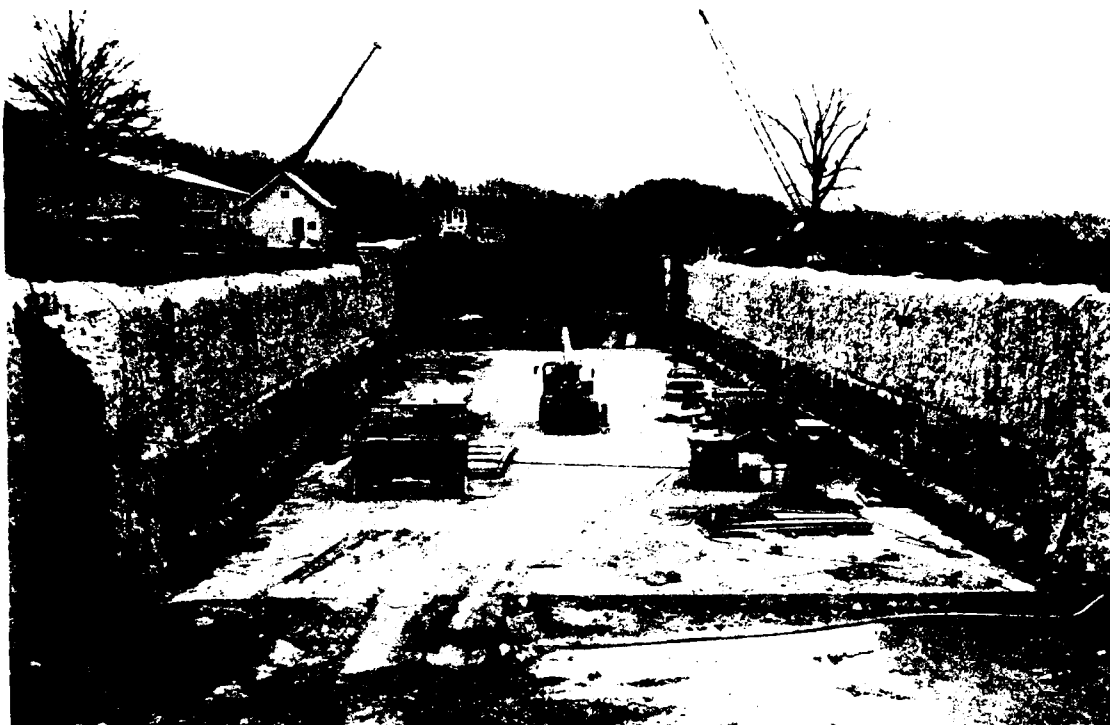
Figure 22. Lock walls following removal of deteriorated concrete, April 1980, Old Lock No. 14, Mississippi River

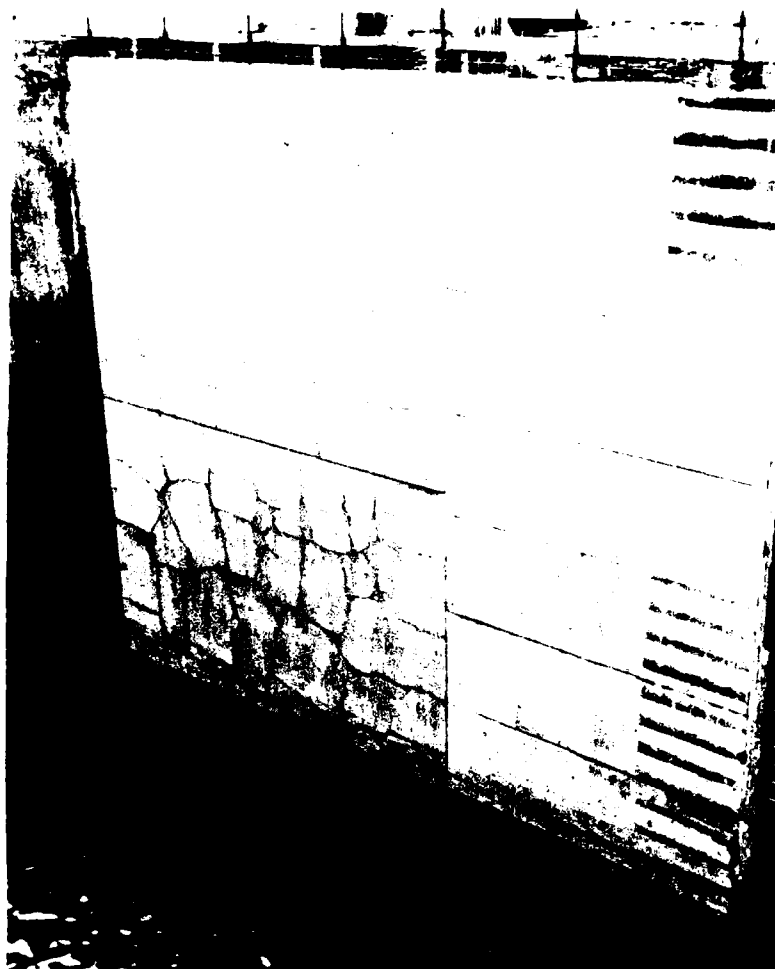
Figure 107. Concrete cracking in a resurfaced monolith (left) compared to reconstructed monolith, Lock No. 1, Mississippi River

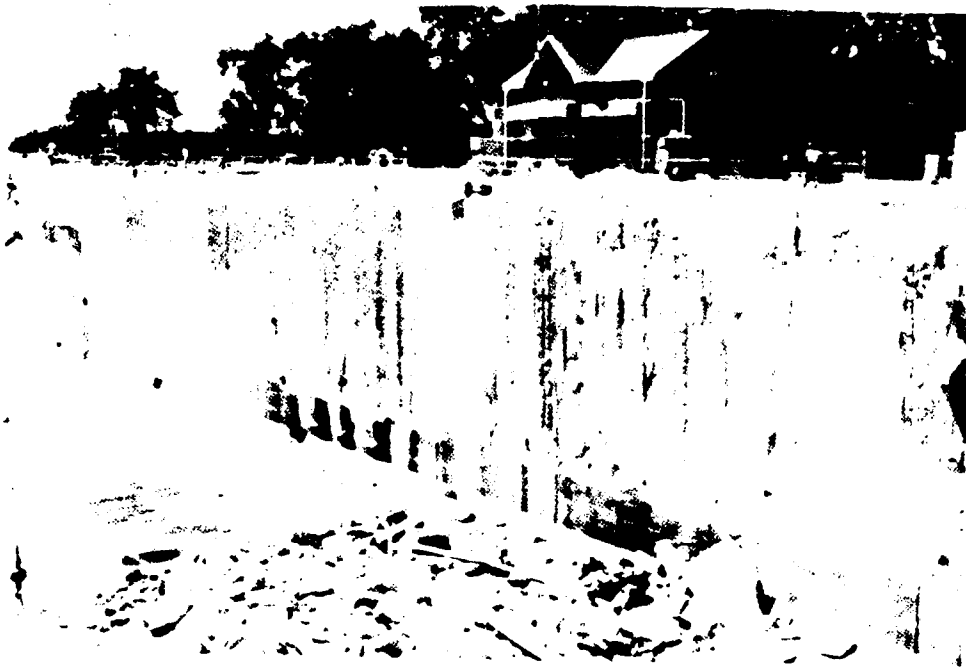
Figure 166. Typical concrete surface conditions following blasting, Brandon Road Lock
